OK so this may have been covered before, if so please can someone add references...

This all started with trying to get the air con working after a quarter century...ended up replacing the compressor by dropping the subframe and in the process replacing the subframe mounts. Accidentally hit the brake wear sensor cable with a hammer whilst trying to do something that probably didn't require a hammer, so decided to refurb the heavily deteriorated brake wear and abs sensor cables. Tried removing the ABS sensor, big mistake.

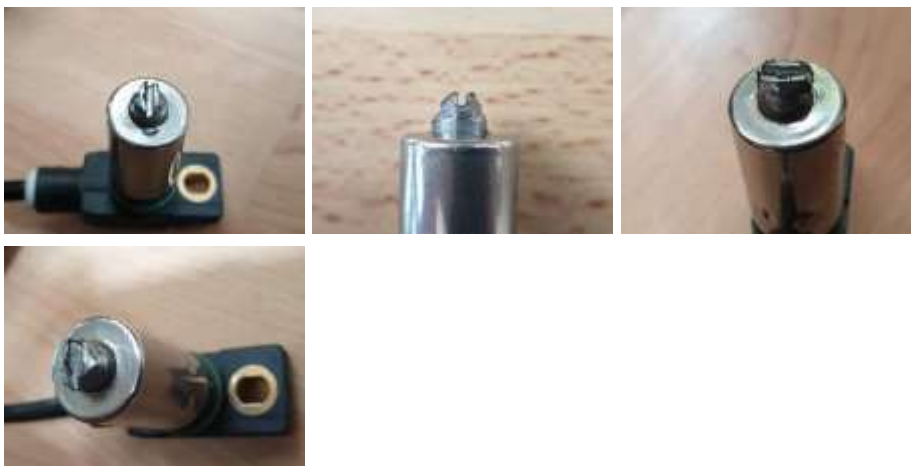
I was careful to cut the groove in the tip to match the original *perpendicular* to the axis of the sensor head.

Some close up pics of the modified Volvo/Lemark sensor tip:

I used a combination of dremel, hand files and hacksaw to cut the sensor tip down and shape it the same as the original MB sensor. This photo shows the new volvo sensor (right) and the modified version to fit the 107 (left).

Once I was done fettling the tip I was able to get something looking like this. What's left of the original MB sensor is on the right, the modified Volvo sensor on the left.
